BOROUGH OF CHRISTCHURCH

PLACE MILL

GENERAL INTRODUCTION

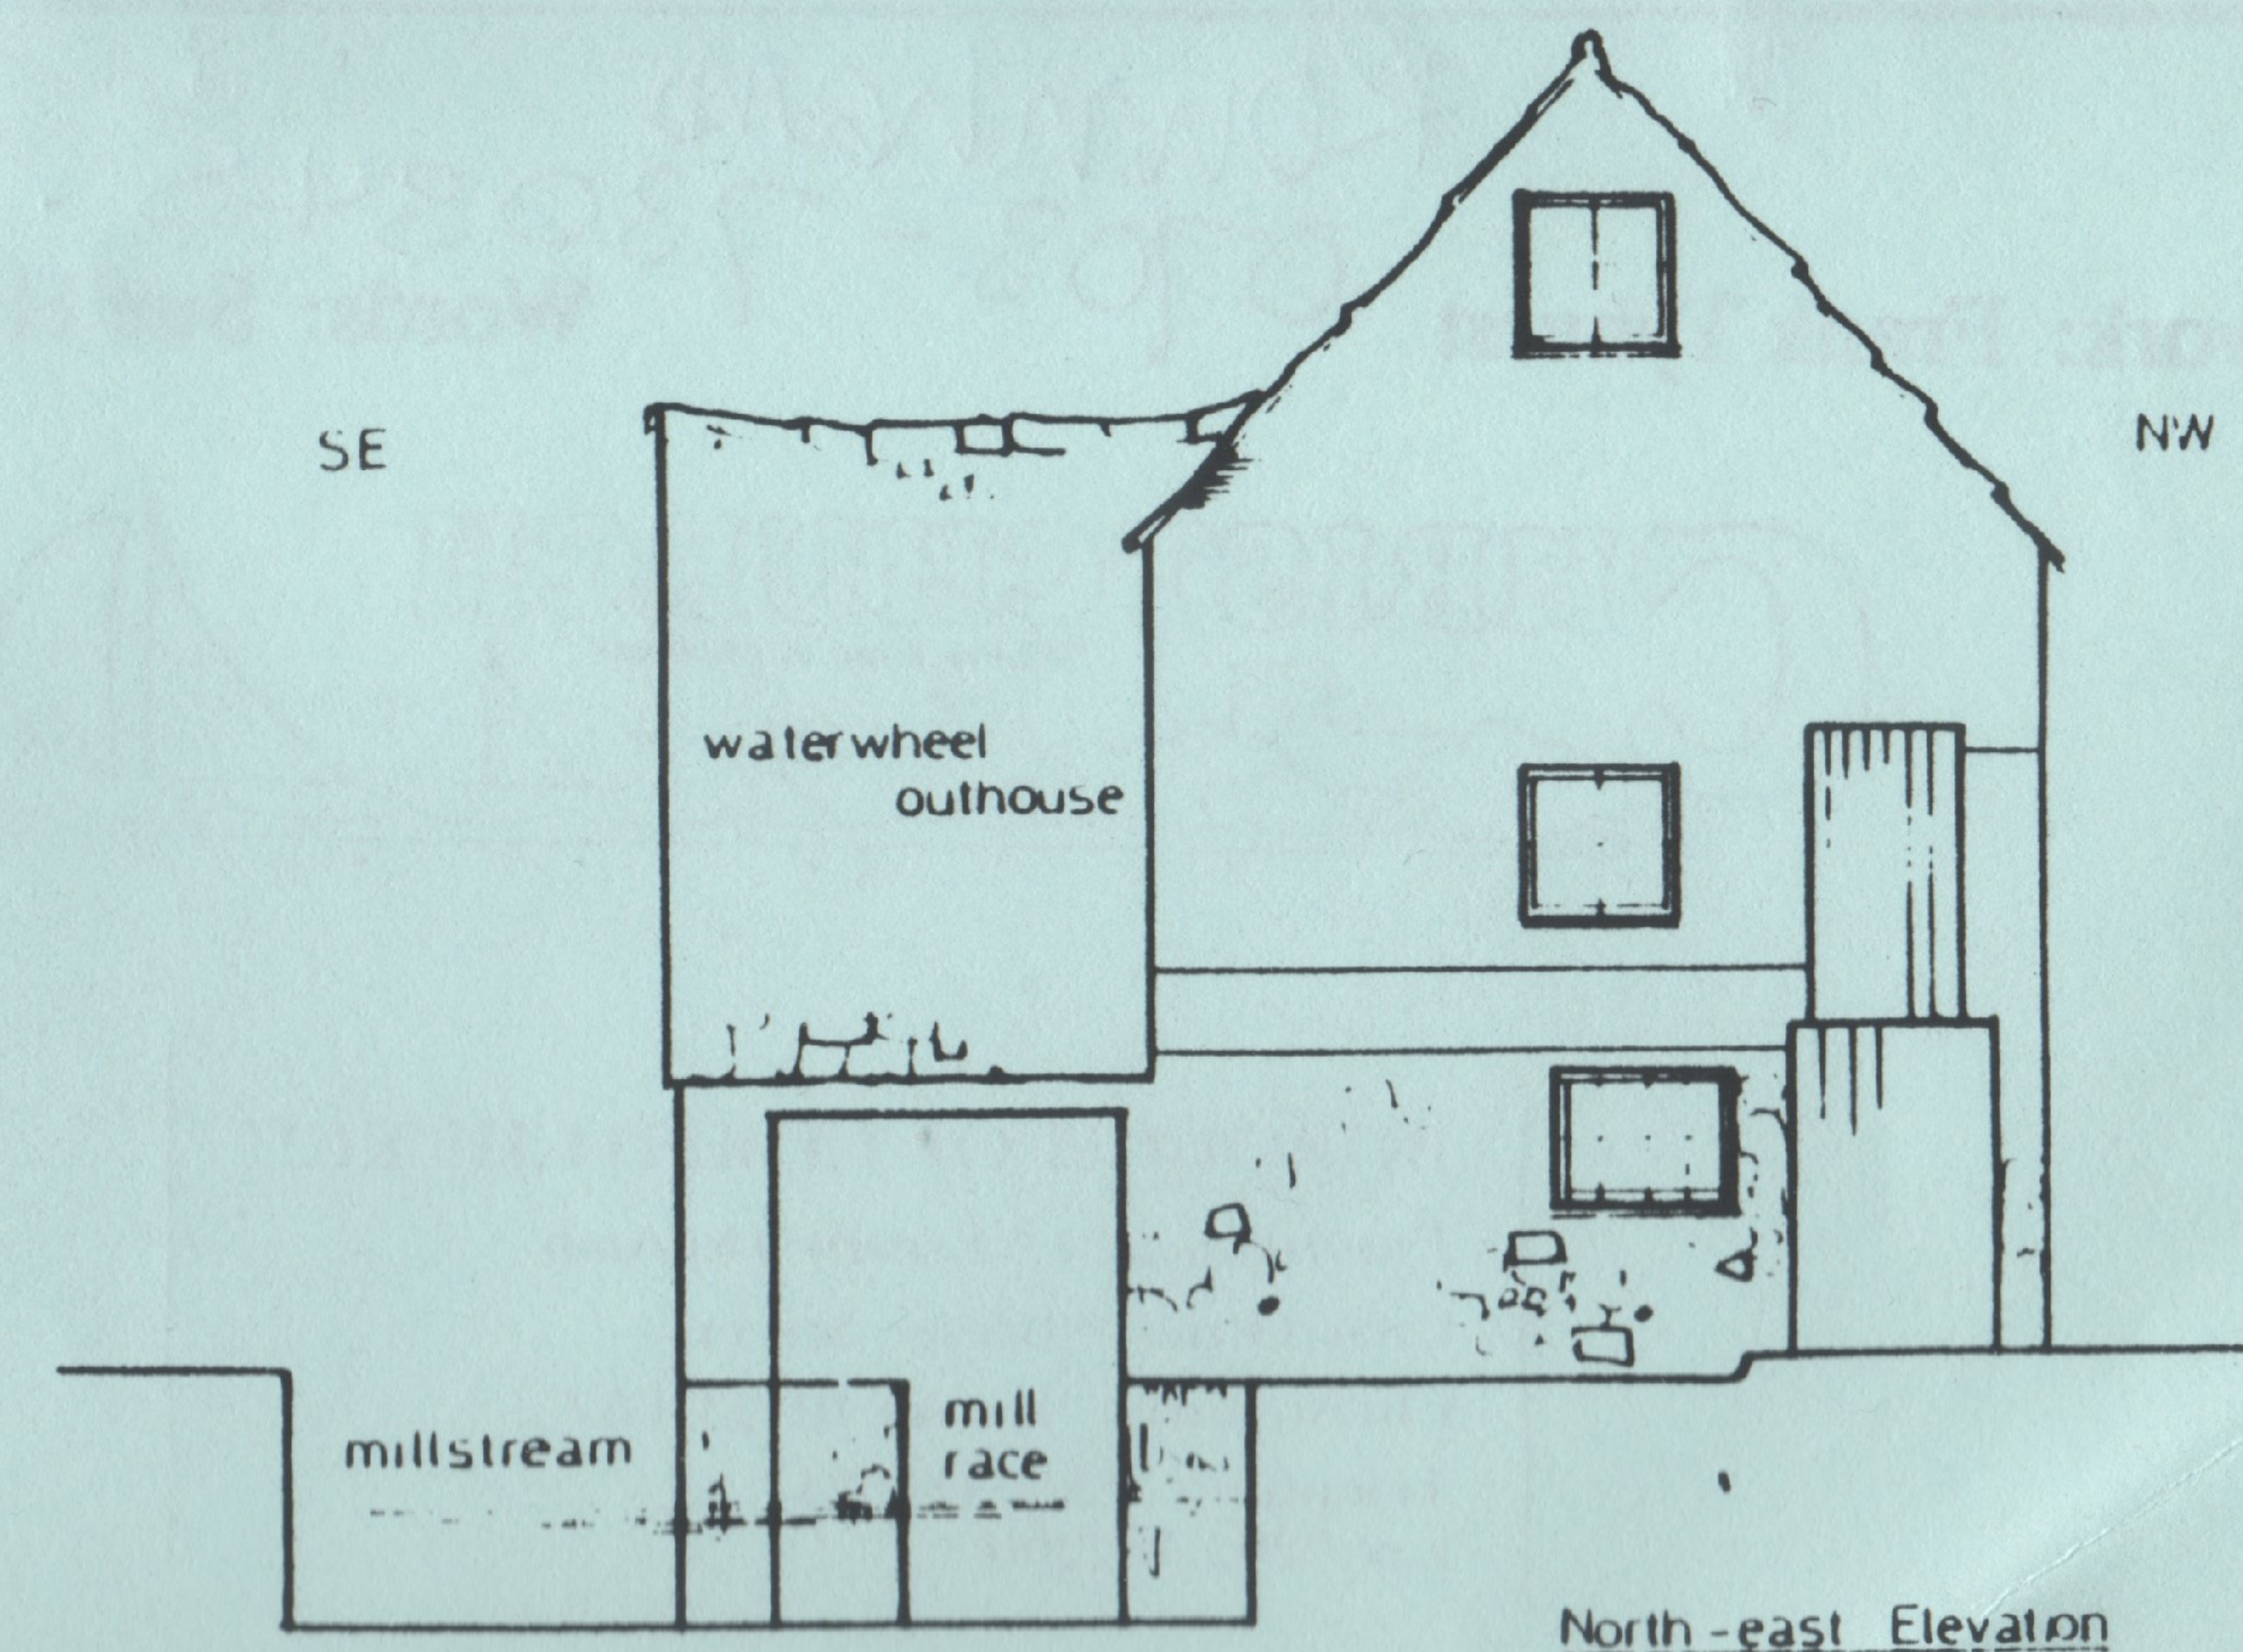
Prominent Elevations

PLACE MILL, TOWN QUAY, CHRISTCHURCH
